# Manhole Inspection Summary

Manhole # S19C\_\_005MH

Insp Date: **4/24/09 1:39 PM**

**Location** Address: **547 PULASKI ST**

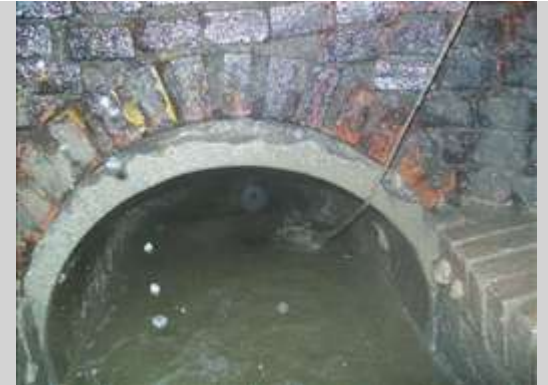
12 O'Clock Outflow

27 in. Circular Gravity Sewer  
Pipe Out @ 12 O'Clock

Pipe Height: **24** (in.) Rod and Bar  
Pipe Material: **Clay** ☐ Pipe Lined  
Invert Depth: **23.71** (ft.) Flow Characteristics: **Fast**  
Deposits: ☒ None ☐ Mud ☐ Sludge ☐ Debris ☐ Grease  
Silt Depth: (in.) Deposits Extent:  
Infiltration: **None** Pipe Seal Cond: **Sound**

Drop: **None**

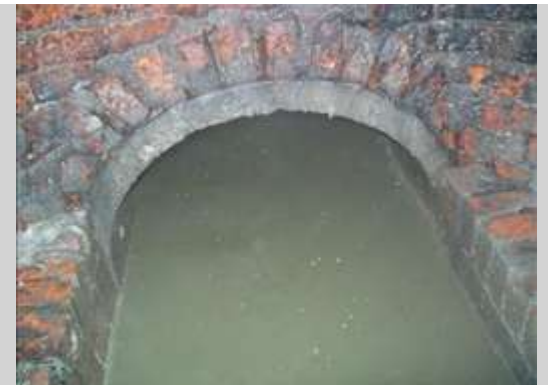
6 O'Clock Inflow

27 in. Circular Gravity Sewer  
Pipe In @ 6 O'Clock

Pipe Height: **24** (in.) Rod and Bar  
Pipe Material: **Clay** ☐ Pipe Lined  
Invert Depth: **23.85** (ft.) Flow Characteristics: **Fast**  
Deposits: ☒ None ☐ Mud ☐ Sludge ☐ Debris ☐ Grease  
Silt Depth: (in.) Deposits Extent:  
Infiltration: **None** Pipe Seal Cond: **Sound**

Drop: **None**
